NR/NA Containment Improvement

Concept of Upgrade Solution

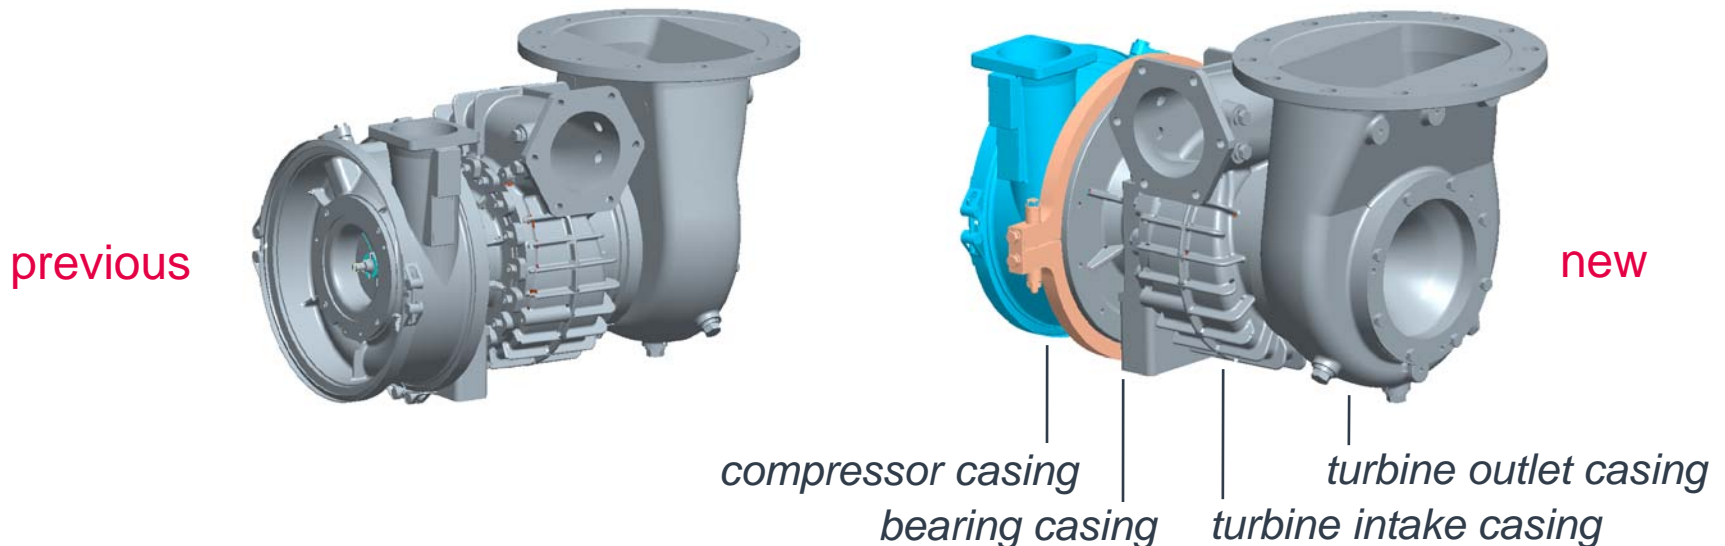
Example of modification (NR turbocharger)

With NR and NA turbochargers, the casings and/or the flange connections are not sufficiently strong to withstand extreme load situations which may for example occur in the very rare case of a rotor failure.

- Modification of the casing design (compressor casing, insert piece)
- Modification of connection of compressor and bearing casing
- Scope (number of components) varies per turbocharger type

- The upgrade kit comprises all required parts to perform the upgrade (including sealing rings etc)
- In some cases the turbocharger has to be lifted from the engine to install the kit
- In some cases a rib of the foot holding the turbocharger must be grinded
- Assembly time depends on scope (4 - 24 h)
